Joint Environmental Management of the River Tana - WP2 Migration barriers

Joint summary report (2017-2019)

**JOINT ENVIRONMENTAL MANAGEMENT OF RIVER TANA–WP2 MIGRATION BARRIERS
JOINT SUMMARY REPORT (2017-2019)**

Center for Economic Development, Transport and environment for Lapland

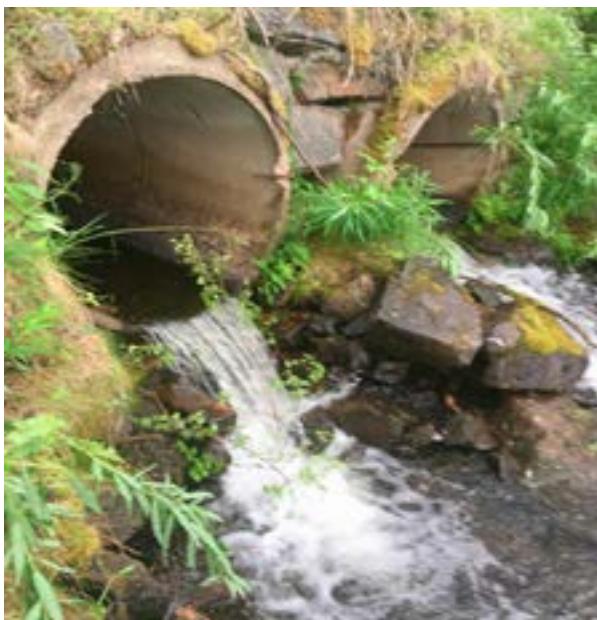
From restored sites after the year 2000, road culvert in Vuolit Boratbokcájohka I (lower branch) was still a migration barrier. At the survey done by the Center for Economic Development, Transport and the Environment (ELY) in summer of 2018, the estimated drop at road culverts in Vuolit Boratbokcájohka was around 40 cm from the pipe outlet to the surface of the channels water. Another measurement done by Natural Recourses Institute Finland (LUKE) later in the year 2018 the drop was estimated as 60 – 70 cm.

Figure 2. Vuolit Boratbokcájohka before restoration.

The restoration work started in July 2019. Matti Kylmäniemi from Natural Recourses Institute Finland advised and supervised the installation of the blasted stones (quarry). He knew that during the spring flood, the water would completely fill the drums. The juveniles rise to the tributaries of the River Tana immediately after the spring flood. After the restoration, the threshold is 15 cm enabling the fish migration. Restoration of Vuolit Boratbokcájohka was done by Finnish infrastructure company Destia Oy 29.7 – 1.8.2019.

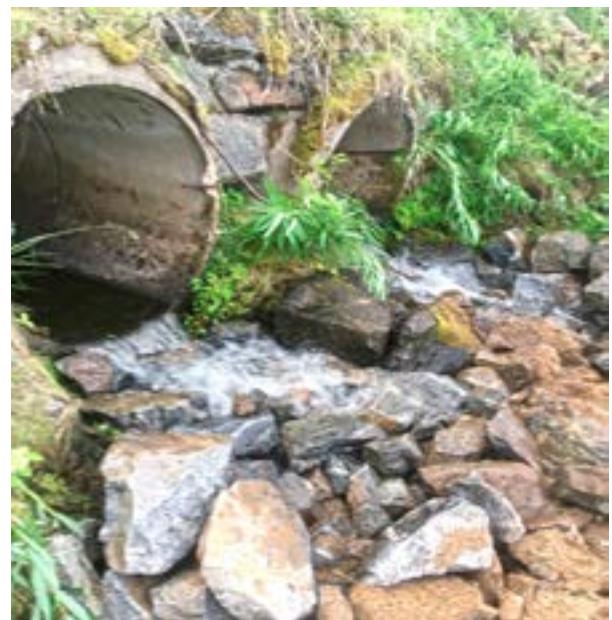
Figure 3. Vuolit Boratbokcájohka after restoration.

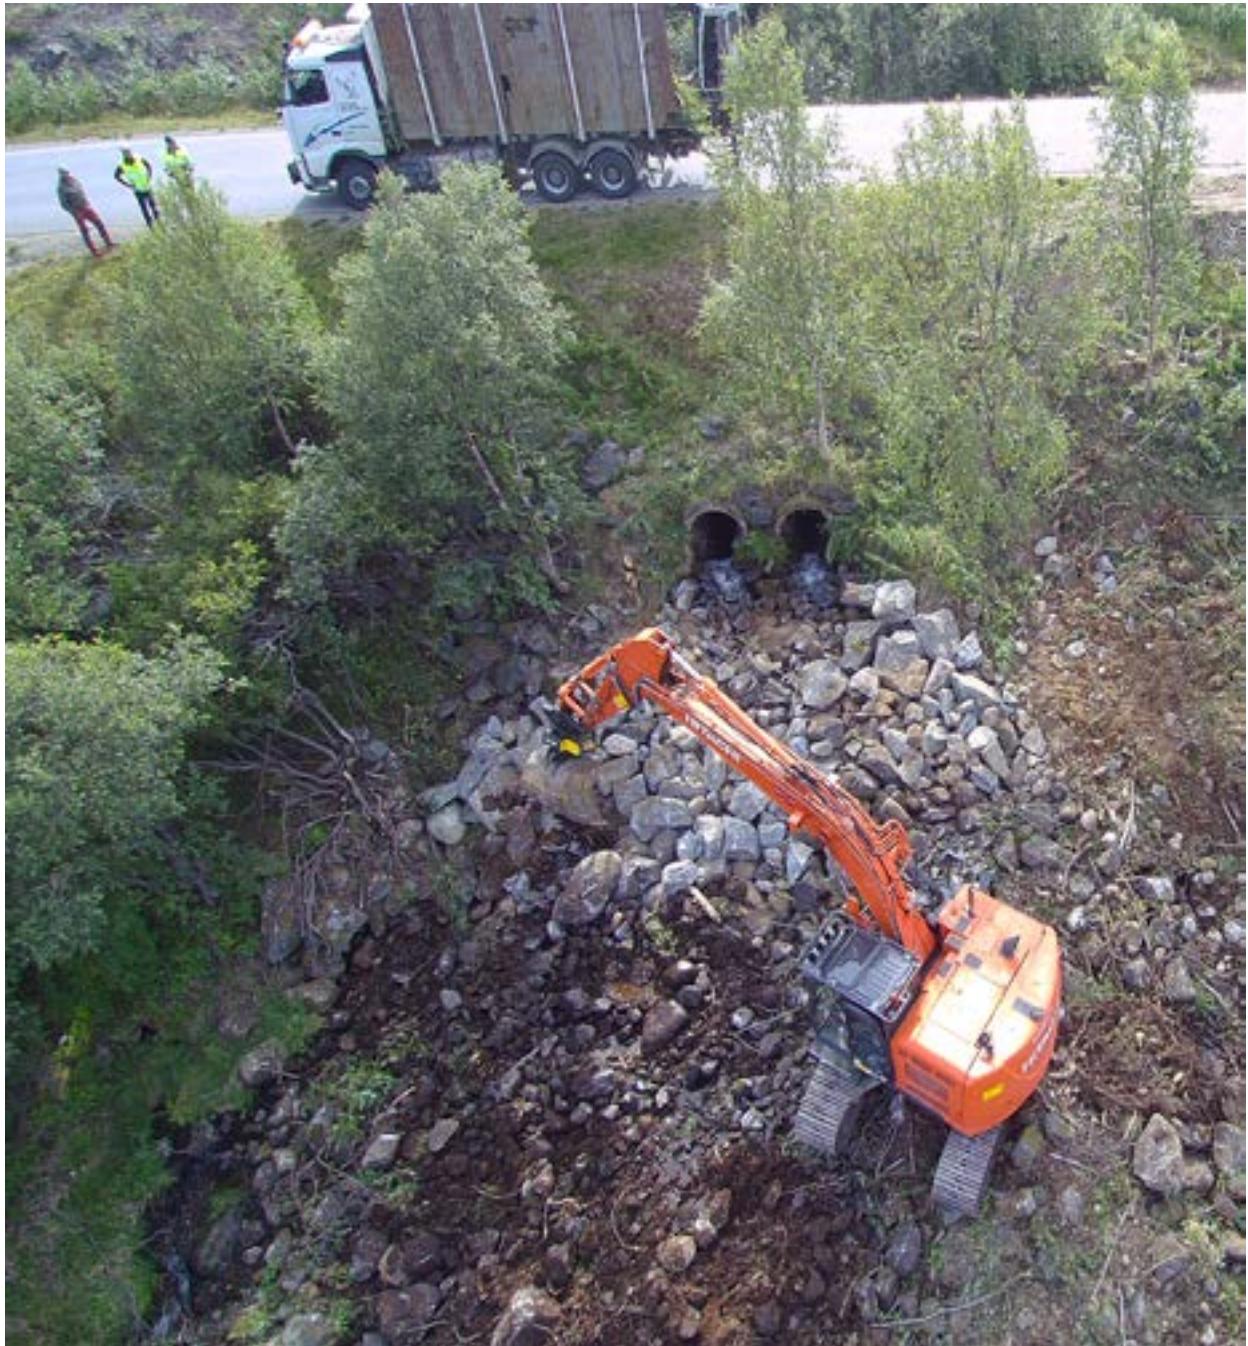
Figure 4. Vuolit Boratbokcájohka during restoration.

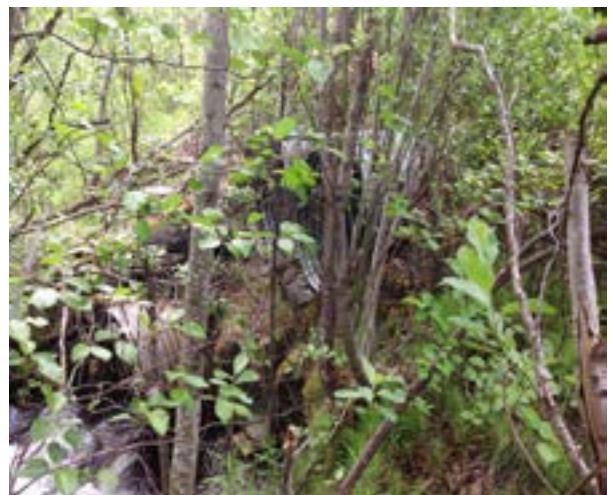
Vuohppejohka is a side- river that was surveyed in 2004 and re-surveyed in 2013 and 2014. Two sites had barriers for migrating fish on the stretch from the main river to lake Vuolit Vuohppejávri. The lower site consisted of a road crossing on a private road with 5 culverts creating a barrier (fig. 5). The drop from the outlet of the lowest culvert to the water surface was 20 cm. On the main road, another site with one culvert created a drop of 75 cm (fig.7). This culvert was restored in 2019 by the Public Roads Administration and Finnmark county (fig 8). The culverts on the private road have not been removed. However, in 2019, as a part of this project as threshold was built downstream the culverts to increase the water lever and enable fish

Figure 5. Culverts on the private road at Vuohppejohka.

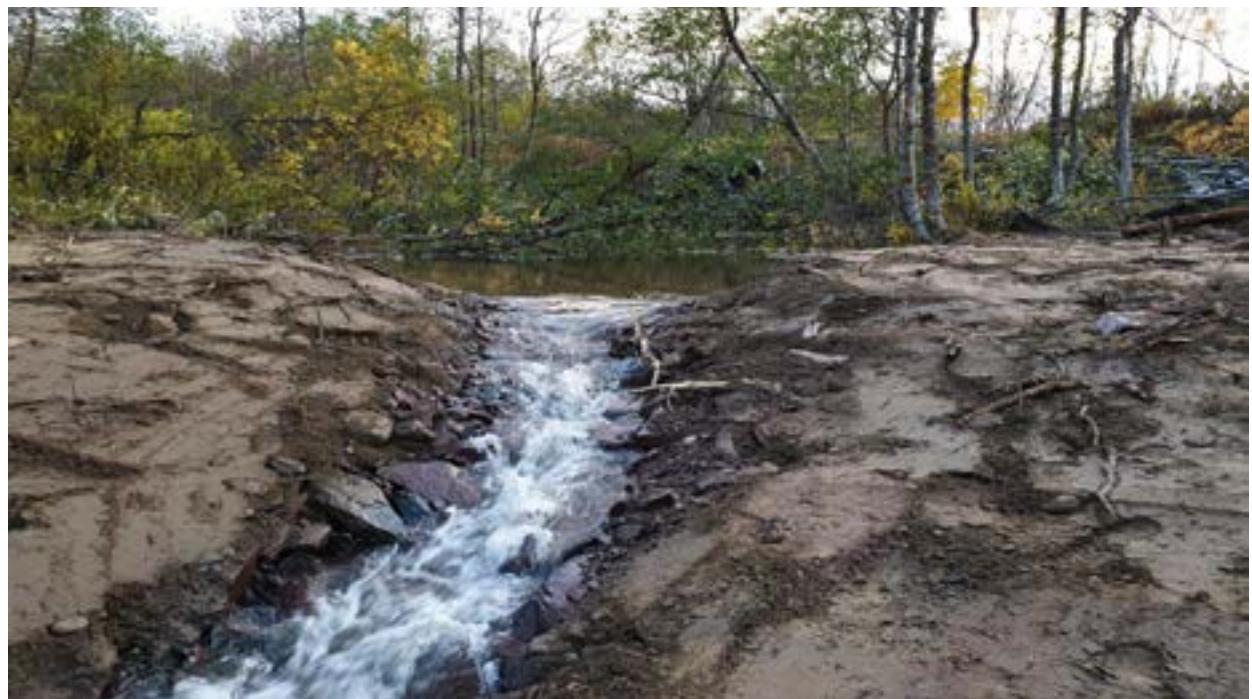
Figure 6. The threshold built to increase the water level Vuohppejohka (private road).

passings (fig.6).

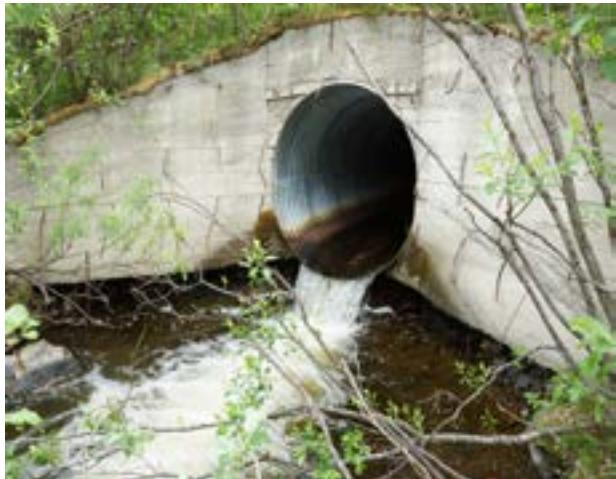
Figure 7. Vuohpapejohka before the restoration (main road).

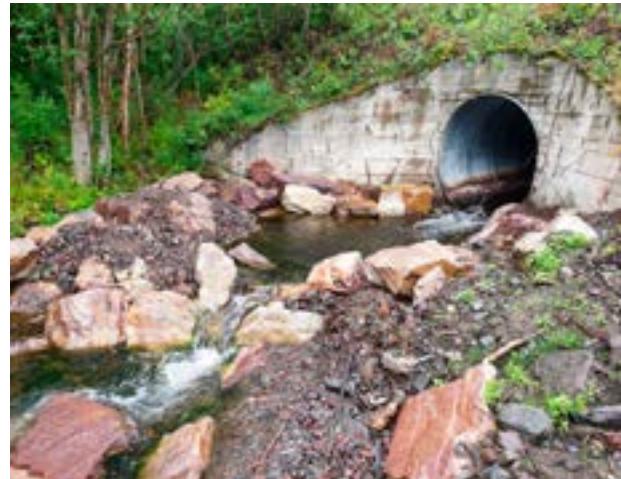
Figure 8. Vuohpapejohka after the restoration (main road)..

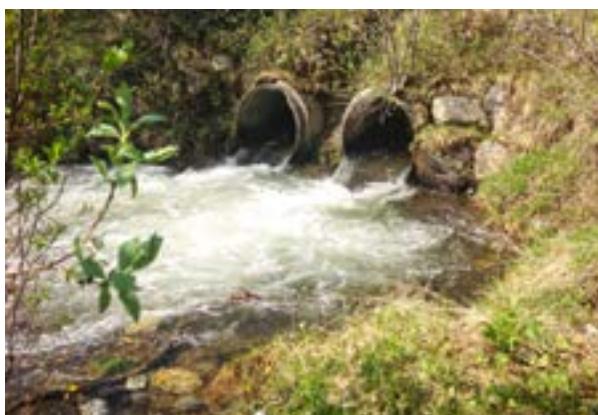
1980's with two culverts creating a barrier for migrating fish (drop of 50 cm and high water velocity) (fig 8). Electrofishing in 2004 and later in 2017 documented salmon parr below the culvert, but only a few individuals upstream the road crossing. The two culverts were replaced in 2019 as a part of our Interreg project with a new and larger culvert. A threshold was also created above the road crossing to lower the height difference and decrease the water velocity (see photoes 9,10 and 11).

Figure 9. Lišmmajohka before the restoration (Photo: NVE nord).

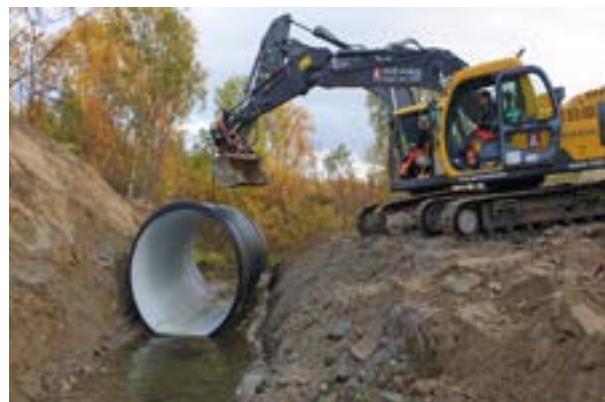
Figure 10. Figure 10 Lišmmajohka during the restoration (Photo:NVE nord).

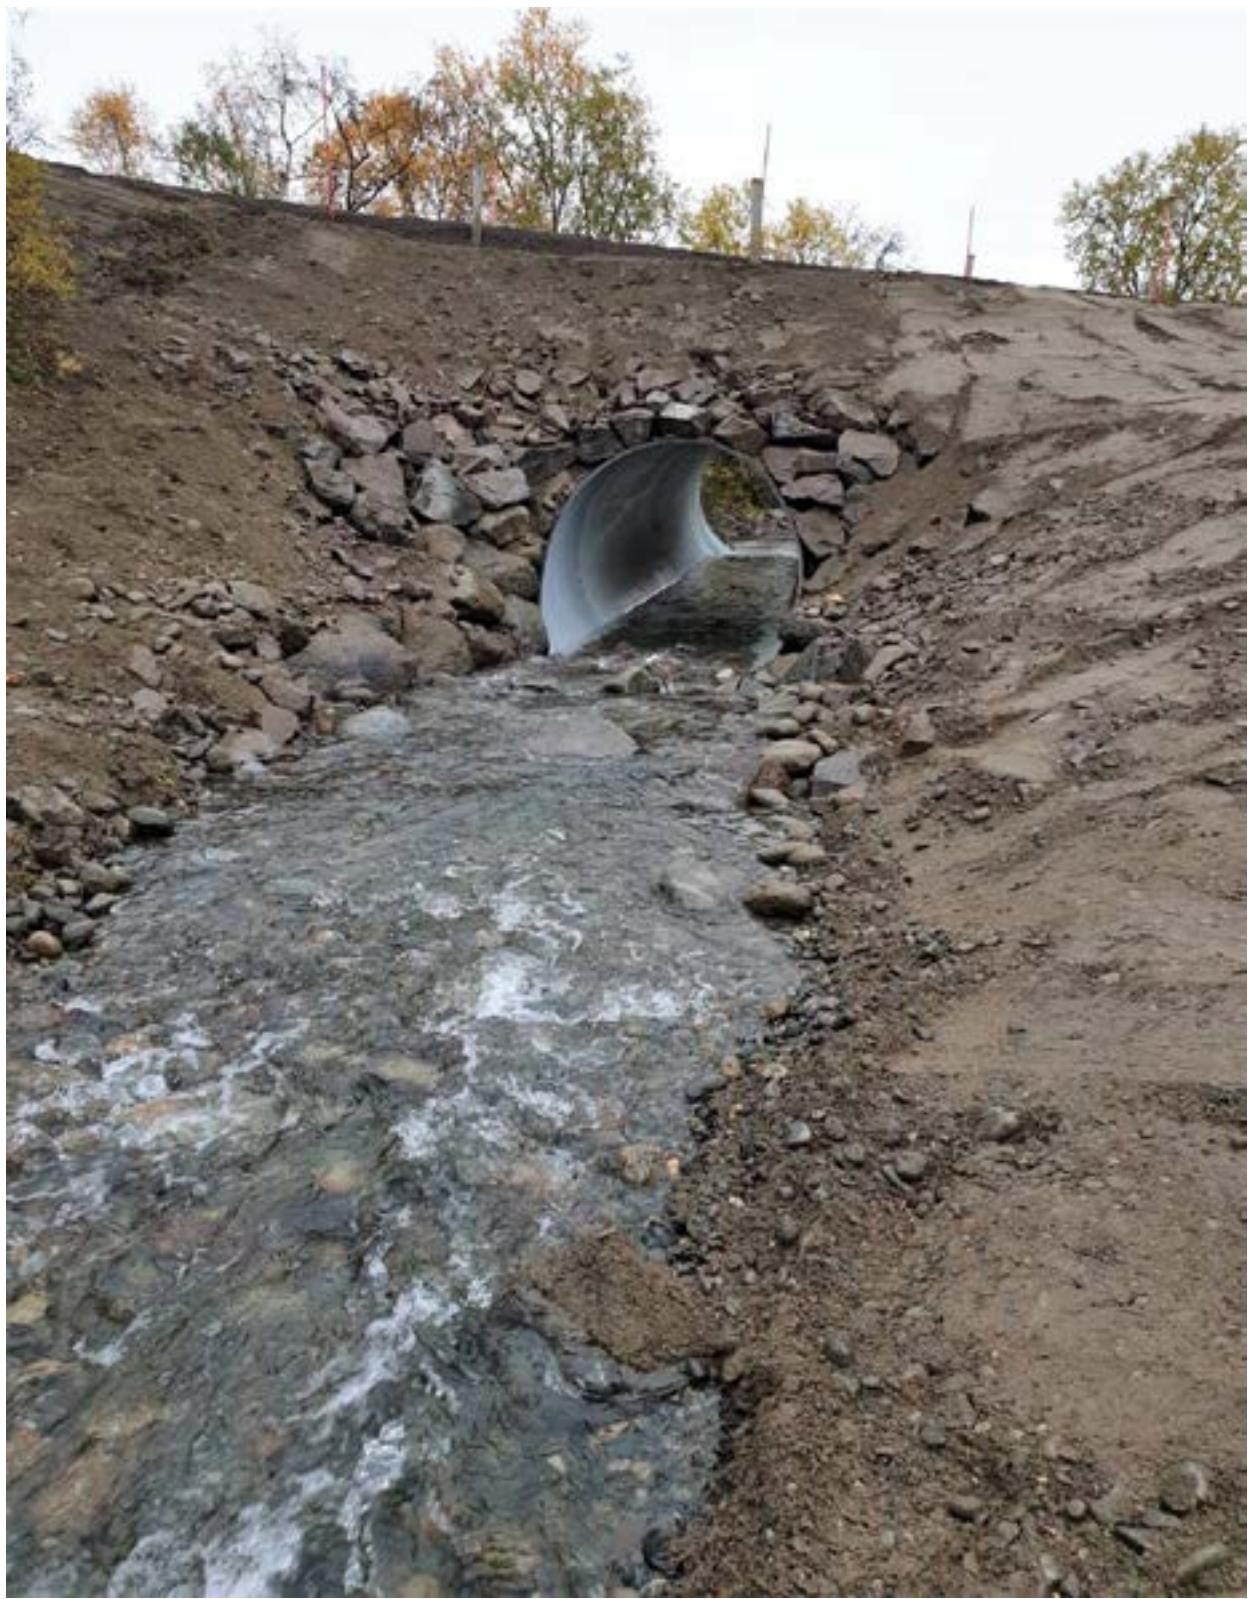
Figure 11. Lišmmajohka after the restoration (Photo: NVE nord).
