Examples and experience from restorations along Tana river on the norwegian side

Knut Aune Hoseth
Head of northern region

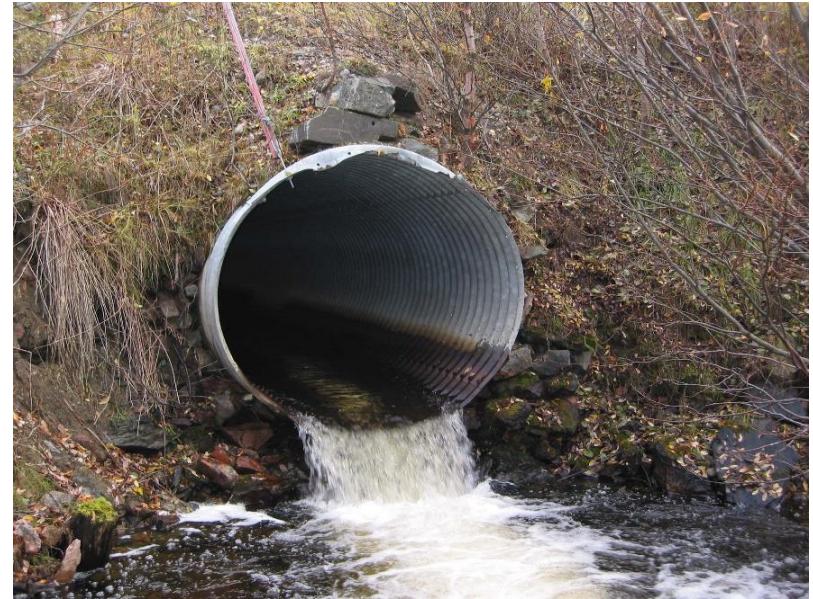
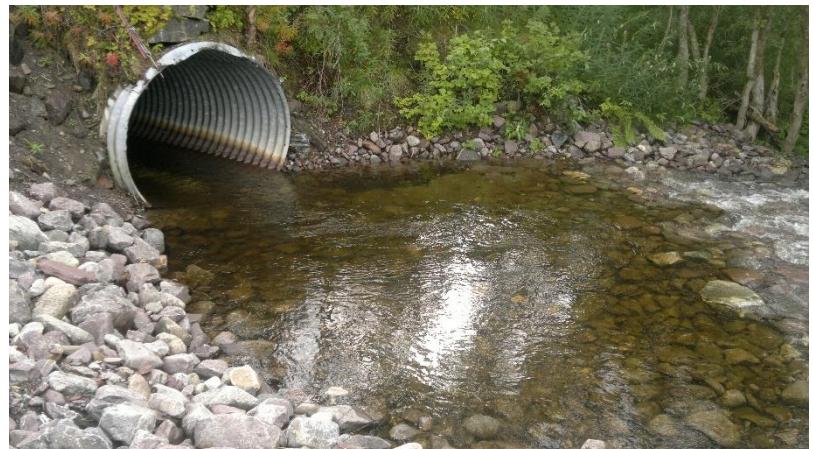
10 Alletjohka, high priority located 4 km downstream Polmak river

- Situasjon:
 - Bredde elv ca 5m og 500 m elv ndf vei, ovnf vei ca 250 m
 - Tetthet laksunger er 16/100 m² ndf vei
 - Tidligere fisk ovnf vei
- Utbedring:
 - Terskler, heve undervann ca 1m
 - Litt opprydding ovnf vei

Restoration by Statens vegvesen

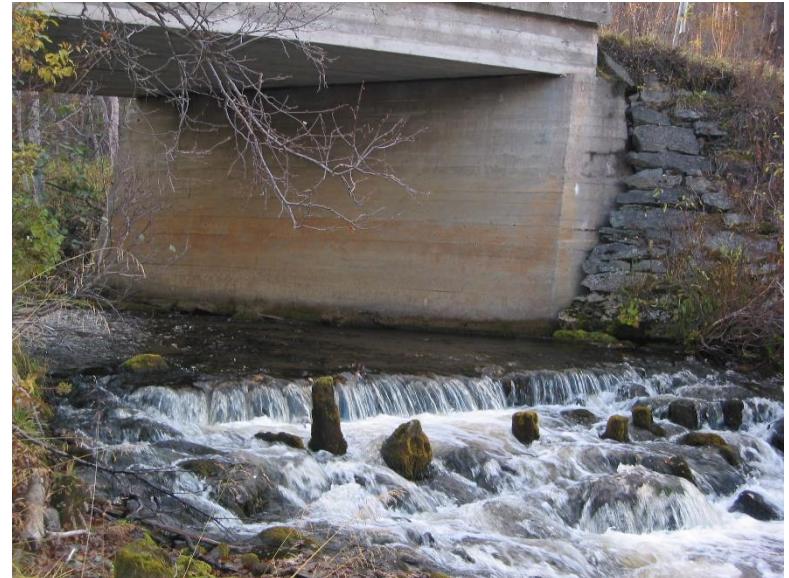
26, Vandringshinder ved Bannegallajohka/Gulbojok

- Situasjon:
 - Bredde elv ca 5 m og 500 m elv ndf vei, ovnf vei ca 4 km
 - Tetthet laksunger er liten ndf vei
 - Sannsynlig oppgang på gunstig vannføring
 - Vandr.hinder ved gamle brufundamenter
- Utbedring:
 - Skade på vei – ny bru og utbedring i 2004 (Vegvesen)

Restoration by Statens vegvesen

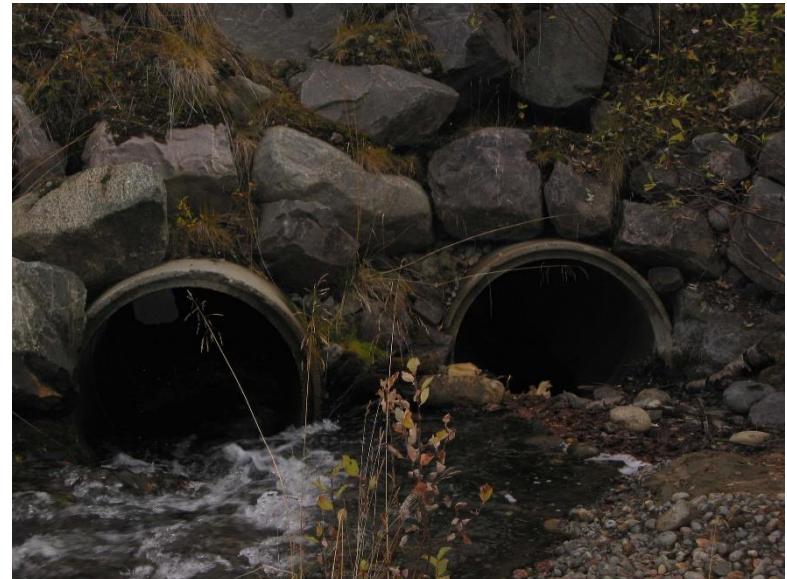
21, Kulverter i Lismajohka

- Situasjon:
 - Bredde elv ca 4m og 200 m elv ndf vei, ovnf vei ca 4 km
 - Tetthet laksunger er 16/100 m² ndf vei
 - Veibru lenger opp OK
 - Tidligere fisk ovnf usikkert
- Utbedring:
 - Terskler, heve undervann ca 0,7m

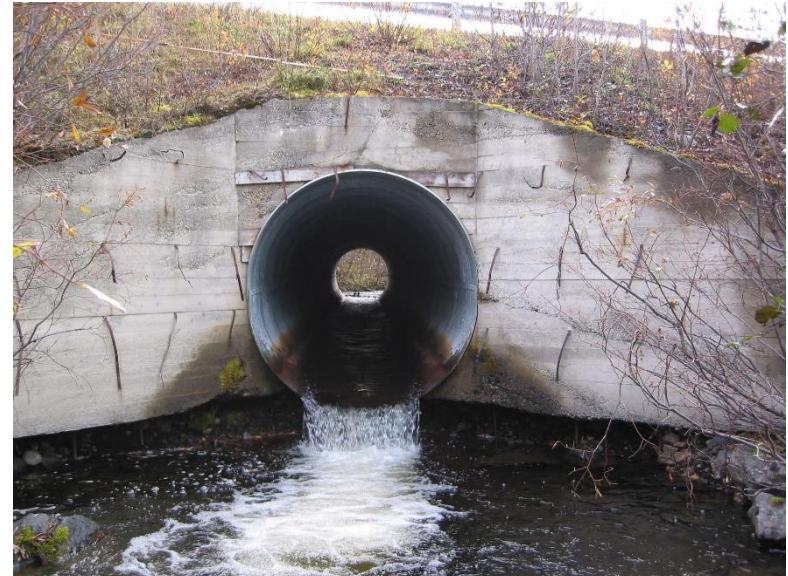
11, Bunnsenkning ved kulvert i Vuohppejohka

- Situasjon:
 - Bredde elv 2-3 m og 500 m elv ndf vei, ovnf vei ca 2,5 km
 - Tetthet laksunger er liten ndf vei
 - Begrenset potensiale ovnf vei
- Utbedring:
 - Terskler, heve undervann ca 0,8m
 - Noe opprydding ndf vei

- Migration barrier by both private road and main road
- Measures has to be decided and planned in more detail as part of this project. NVE will take care of this planning
 - Most probably construct weir constructions to rise the water level below both roads
