FISH MIGRATION BARRIERS IN THE RIVER TANA TRIBUTARIES Summary of field work in Norwegian tributaries (2015-2016)

Interreg- project "Joint environmental management of the river Tana" (WP2)

Anne Fløgstad Smeland (County Governor of Troms and Finnmark-FMTF) and Narve S. Johansen (Tanavassdragets fiskeforvaltning-TF) (2019).

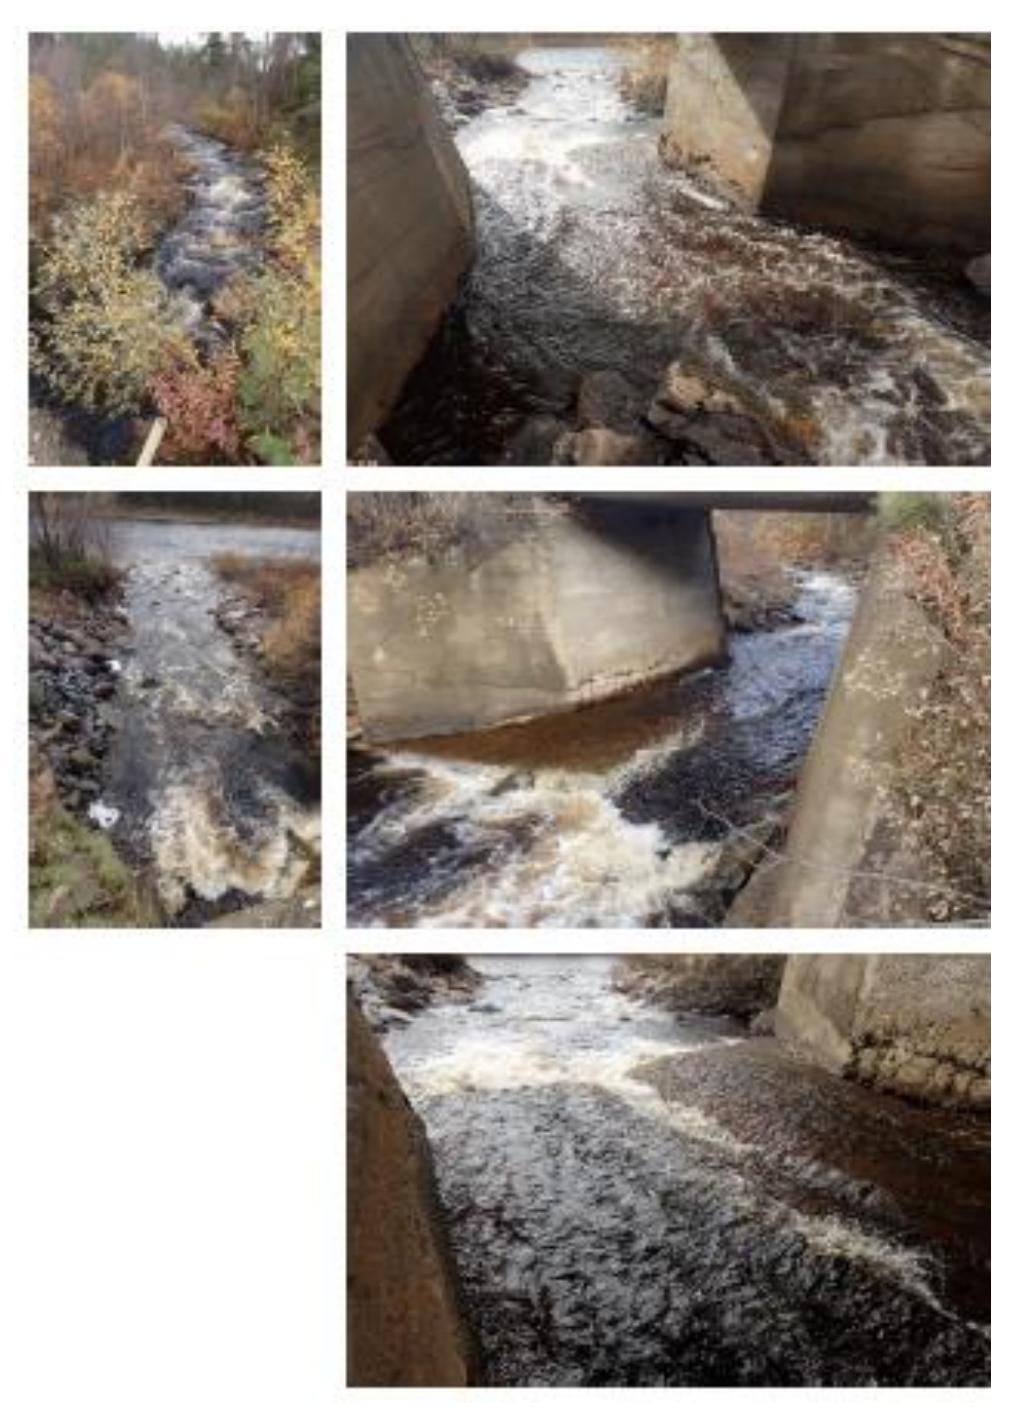
2.1. Čáhppesjohka (Ánarjohka, Karasjok municipality)

The bridge below Čáhppesjohka is a migraion barrier for the smallest fish. Electro fishing below the bridge detected 5 salmonids (92-123 mm) and two trouts (80-87 mm). Adding of stones under the bridge would make the bridge easier to cross for younger fisk. Measures are considered not to be very costly.

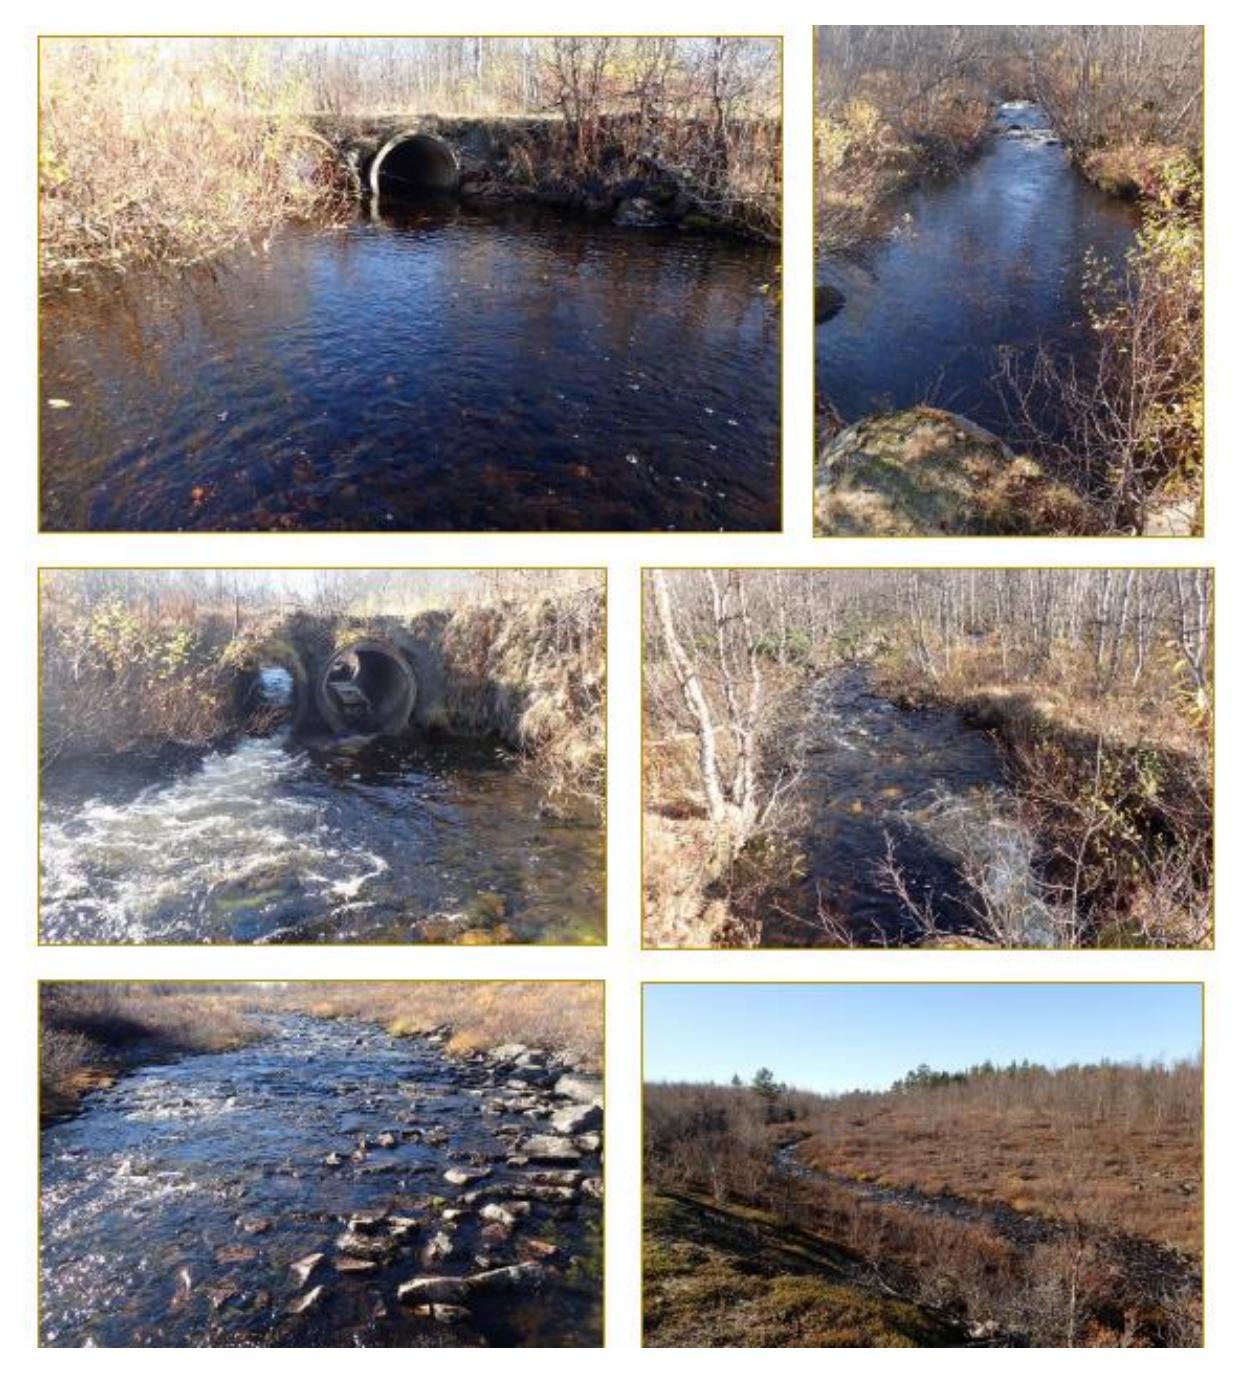
2.2. Ráitejohka (Ánarjohka, Karasjok municipality)

The lowest culvert (A28) is a migration barrier for smaller fish. The stream has good potential for fish. It is considered a cheap and cost-effective measure to make a threshold below the culvert that increases the water level and thus passage.
