Joint Environmental Management of the River Tana - WP2 Migration barriers

Joint summary report (2017-2019)

**JOINT ENVIRONMENTAL MANAGEMENT OF RIVER TANA–WP2 MIGRATION BARRIERS
JOINT SUMMARY REPORT (2017-2019)**

Center for Economic Development, Transport and environment for Lapland

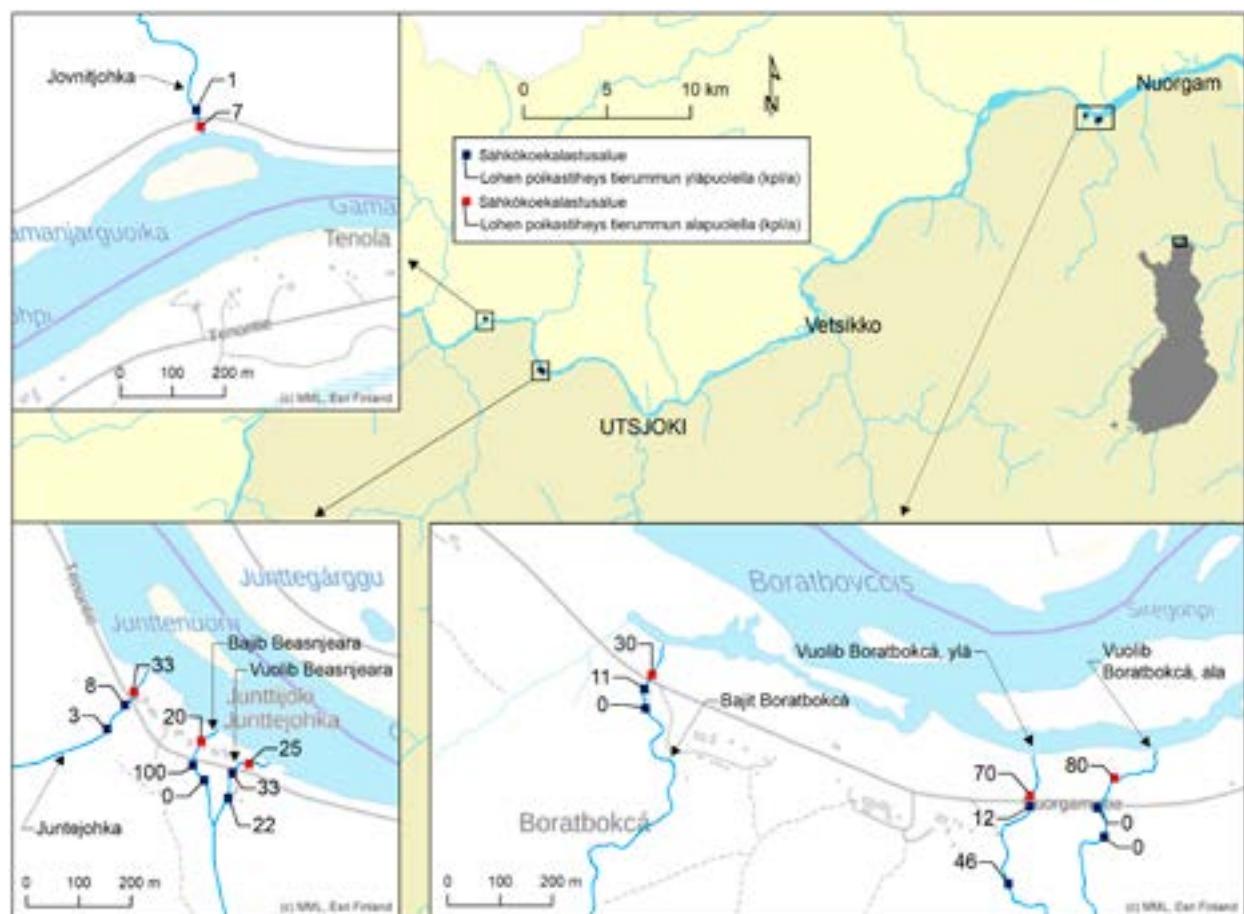
Figure 1. Streams and sites electrofished in 2018 by the Natural Resources Institute Finland (Luke). Numbers at sampling sites denote juvenile salmon densities (fish per 100 m²); sites marked in red are downstream the road culvert; sites marked in dark blue are upstream.

According to the results of the study done by Natural Resources Institute Finland, the culverts seemed to be supporting conductivity in the streams and in most cases the juvenile salmon densities were higher on both sides of the culverts than during the earlier surveys (Figure 1; see also Erkinaro et al. 2017). However, at, Vuolib Boratbokcá the vertical drop below the culvert had increased in height to 60 cm and at least under the late summer flow conditions, the culvert was severe hindrance, if not total barrier to fish migration from down stream. Vuolit Boratbokcá (lower branch) was then restored as a part of this project in July 2019 (more details of the restoration on page 9).
